Inspection Report

Mine Name: Lisbon Valley	Permit number:	M0370088
Operator Name: Lisbon Valley Mining Company	Inspection Date:	January 9.

M0370088, Lisbon Valley Copper Mine, Lisbon Valley Mining Inspection Dated: January 9, 2007; Report Dated: February 7, 2007

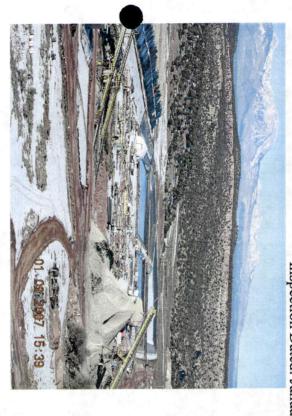
Photo 1. A portion of the processing area with the primary crusher on the right.

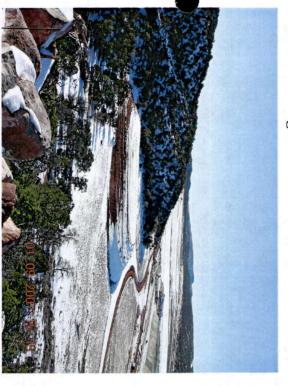
The soil pile near the water tank and to the southwest of the leach pad has been seeded.

Photo 2. The topsoil pile that was seeded.

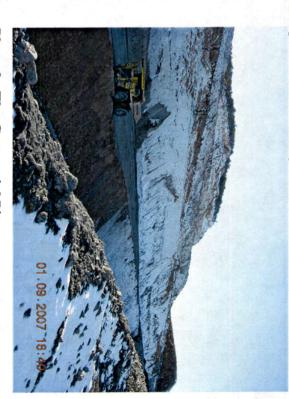
Photo 3. The Centennial Pit.

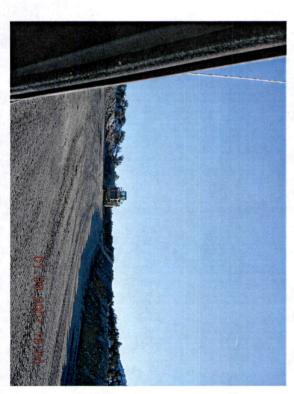
During the inspection, the operator was working to build a road from the Centennial Pit to Waste Dump B using waste material. The area being constructed is over a rocky, pinyon/juniper area where there was probably little soil to salvage, but as the road progresses, the operator should ensure that soil is salvaged where possible.

Photo 4. The beginnings of the haul road to Waste Dump B.

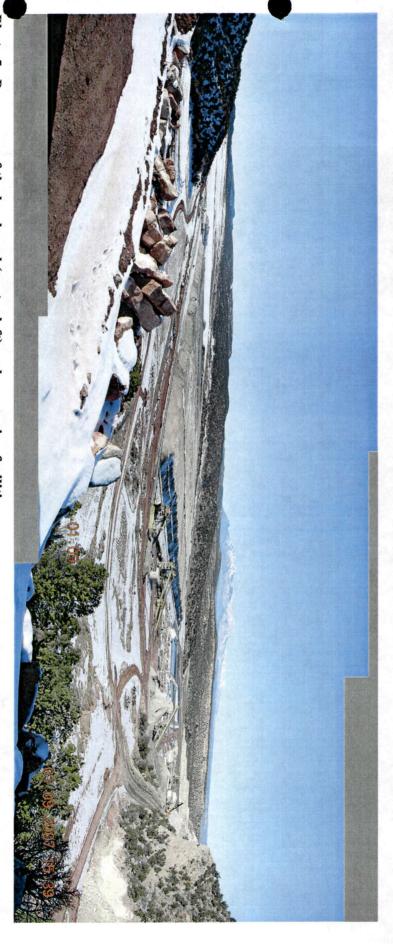
Photo 5. Panorama of the leach pad (center left) and processing facilities.
